# Holistic analysis approach and Design Improvement for Crane sheave early Failure

## II. CRANE SHEAVE EARLY FAILURE INVESTIGATION

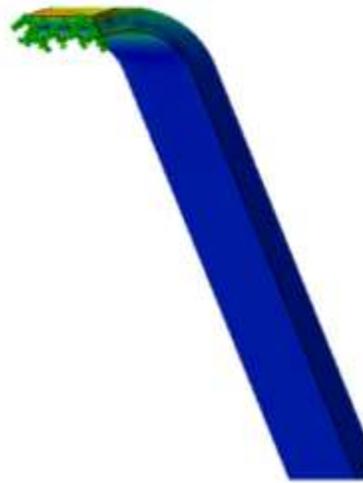
Fig. 6: FE results of conventional design

From figure 6, it is clear that excessive bending stresses are likely, owing to the bending moments caused by radial clearances between the sheave hanger and its sheave pin. These bending stresses will almost certainly exceed the material's limit (i.e. yield stress (YTS)) under some conditions. This is what caused the failure and shave subjected to failure from top edge hence it is necessary to modified design of crane shave. Simple design change which will help eliminate this type of failure. The sheave hanger is fitted with a steel tube welded to its inside radius. The sheave pin is a good 'running fit' in the tube, thus eliminating the variation in radius of the contacting surfaces that caused the imposed large bending moments. The result of modified design is shown in figure 8 with applied load and boundary condition (i.e. inner radius is fixed and bottom portion of shave subjected to loading (figure 7)).

The findings so far are quite typical for a simple mechanical failure event. The results seem clear indication of a fatigue mechanism having been in operation, affecting first the outer radius of the crane sheave hanger bend. The work hardened and coarsened microstructure are significant findings but are mainly consequential caused by the fatigue mechanism, rather than being a separate cause themselves. The operational review has proved useful because it has effectively eliminated operational factors from the cause of failure. Dynamic stress concentrations that will be caused by swinging or jerking of the load are well within the factors of safety built into the crane design. We have shown that excessive bending stresses are likely, owing to the bending moments caused by radial clearances between the sheave hanger and its sheave pin. These bending stresses will almost certainly exceed the material's fatigue limit and possibly also its yield stress (YTS) under some conditions. This is what caused the failure. A simple design change which will help eliminate this type of failure. The sheave hanger is fitted with a steel tube welded to its inside radius. The sheave pin is a good 'running fit' in the tube, thus eliminating the variation in radius of the contacting surfaces that caused the imposed large bending moments. The addition of the tube is a practical step- an equally good solution would be simply to bend the sheave bracket to the same radius as the sheave pin so it sits snugly over it. Practically, this is difficult and it is not easy to achieve close radial tolerances on the inside radius of bends, so the addition of the tube is a better solution
